NATIONAL ADVISORY COMMITTEE FOR AERONAUTICS

No. 496

A PRELIMINARY MOTION-PICTURE STUDY OF COMBUSTION

IN A COMPRESSION-IGNITION ENGINE

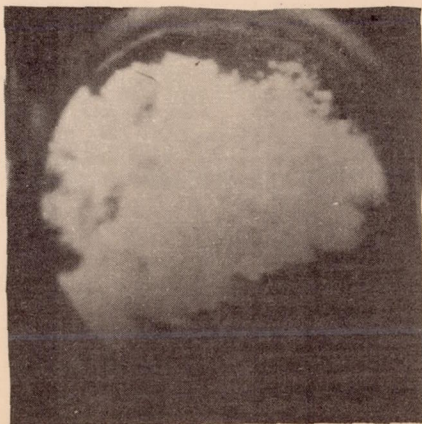
10th. frame  
Flame starting to decrease

chamber. The tenth frame shows the flame continuing to spread but never completely filling the chamber. The other two frames show the flame dying out at the top of the chamber, but continuing to burn at the bottom. The last frame shows the small isolated nuclei of incandescence.

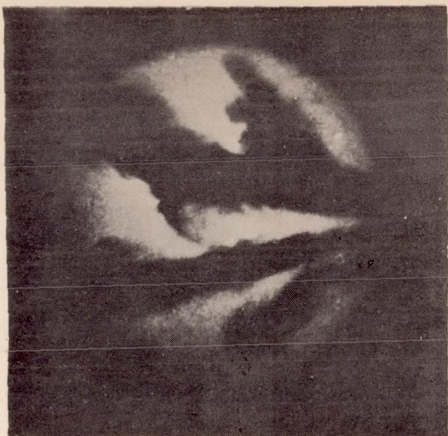
3rd. frame  
Silhouette of spray

Figure 4 shows some enlargements of photographs of the spray and the flame, to slightly less than full size, when injection started at top center. Three frames of the film, of which the third is reproduced in figure 4, show silhouettes of the spray in the chamber. The fourth frame still shows the spray silhouette and also shows the start of the flame in the envelope of one of the sprays. This small flame has a very irregular outline and its brightness varies. The fifth frame shows the flames spread to the edge of the chamber in one direction and to the center of the chamber in the other direction, but still presenting a very uneven appearance. This frame also shows a nucleus of burning in the spray envelope on the opposite side of the chamber. The succeeding pictures show the appearance of the flame as it spread through the rest of the chamber.
